Joshua Goudreault

Northampton JFK: Gym Retrofit

5/10/18

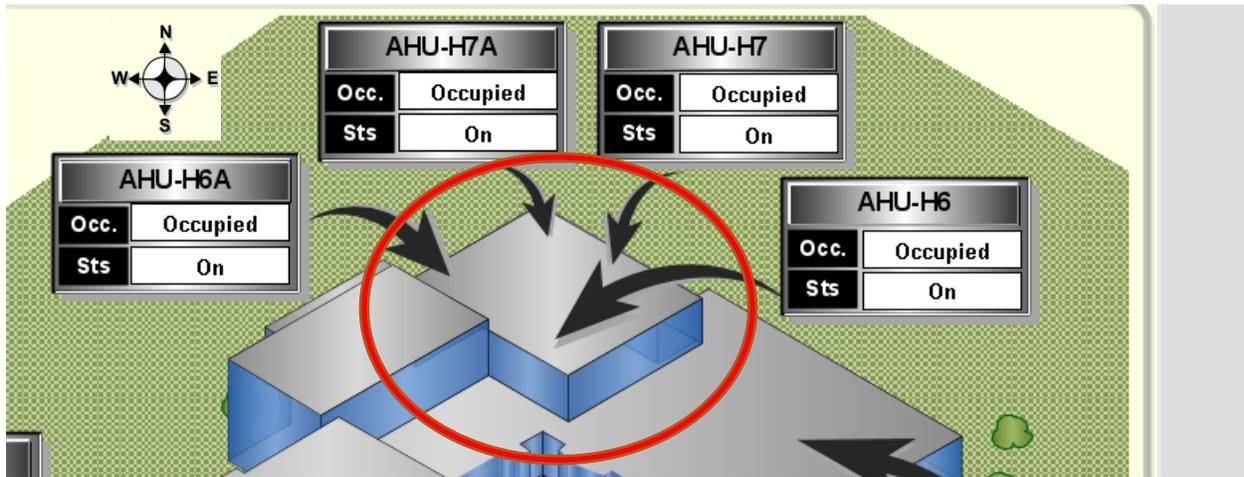
North Wall	West Wall	South Wall	East Wall
Exposure	Fully-Exposed	1/4 Exposed	Half-Exposed	Almost Fully-Exposed
Sound Reducing Slits?	Yes	No	No	Yes

As you can see from the figure above, there are four labeled heating distribution systems (AHU-H6a, AHU-H7A, etc.) for each corner of the gym. These systems force air out and downward toward the lower section of the gym. Regarding the insulation, there is foam board of about R-20 at the ceiling and fiberglass stuffed in between the structural beams at about R-2 pictured below:

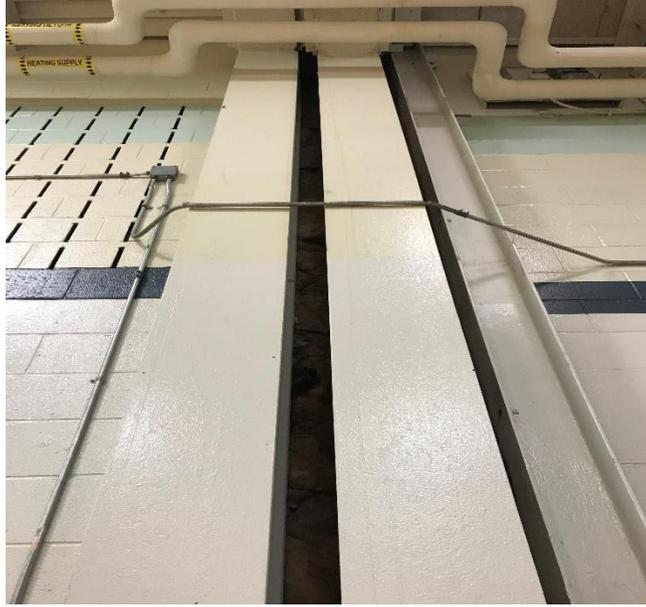
Due to no air barrier and low insulation at the ceiling, cool air enters from above and increases the convection. The cool air drops down below and pushes the hot air up and out through the ceiling. There needs to be a better form of insulation on top of the R-20 and then a vapor-open air barrier.

Conveniently, there are trusses beneath the ceiling at an estimated offset distance of 1 foot. This is an adequate space to fill in with fiberglass insulation as it can easily meet and gain structural support from the trusses while also making it a flush and organized appearance. So, 12" thick insulation would be installed to fill that space and add a substantial R-Value to the ceiling. To both cover the insulation and supply an air barrier, a layer of single bonded low density polyethylene will be attached under the fiberglass and into the trusses. Moisture buildup will occur in this filled cavity, so a high perm air barrier is needed, hence the low density polyethylene. With these two materials there will be both a much higher R-Value (R-63.2) and an air barrier that will successfully block air leakage. Below is a CAD drawing showing the before and after of this proposed solution:

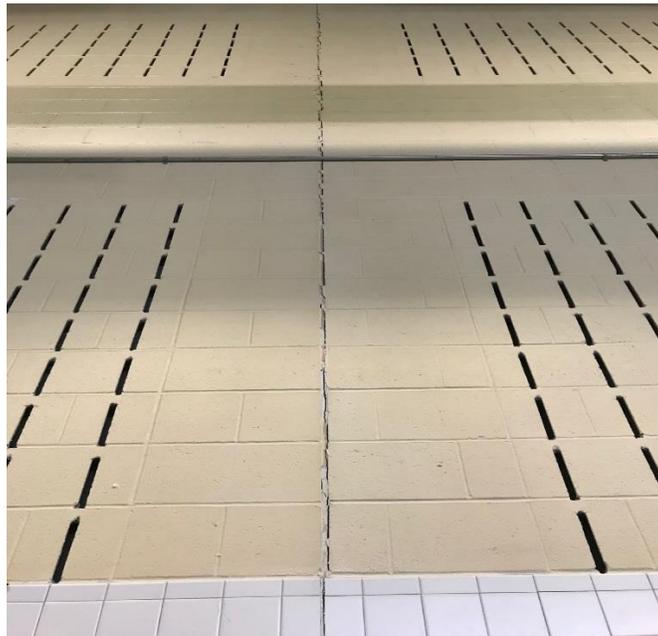
At the walls there is no insulation, making it only R-2.8 due to the 4” external brick (R-0.8) and 8” internal concrete blocks (R-2). Along with this, the gym has no form of an air barrier and there is a large crack on the north wall pictured below:

Air leakage is the first priority here, so a liquid air barrier membrane would be applied to all of the walls. This will be a continuous barrier that covers both the large cracks and sound reducing slits reducing almost all air leakage. On top of that there will be 2x4s drilled into the concrete blocks 27.5" apart on center. In between these gaps, 24" x 1.5" XPS boards will be inserted. XPS is a rigid foam insulation and has an R-Value of R-5 per inch. On top of that layer of 2x4s and XPS, there will be another 2" layer of continuous XPS to increase the R-Value by R-10. Then, 5/8" plywood will be attached through the XPS into the 2x4s and then into the concrete blocks. The plywood will provide the gym with an adequate finish as it is a sturdy material that can stand up to the standard activities that take place in a gym (like basketballs hitting it). An additional proposition is to attach multiple t-nuts into each piece of plywood and add rock climbing holds to increase the recreational value of the gym as well. This is a great opportunity to expand the activities that the gym offers while also supply it with an air barrier and a form of insulation. Below is a CAD drawing showing the before and after of this proposed solution:

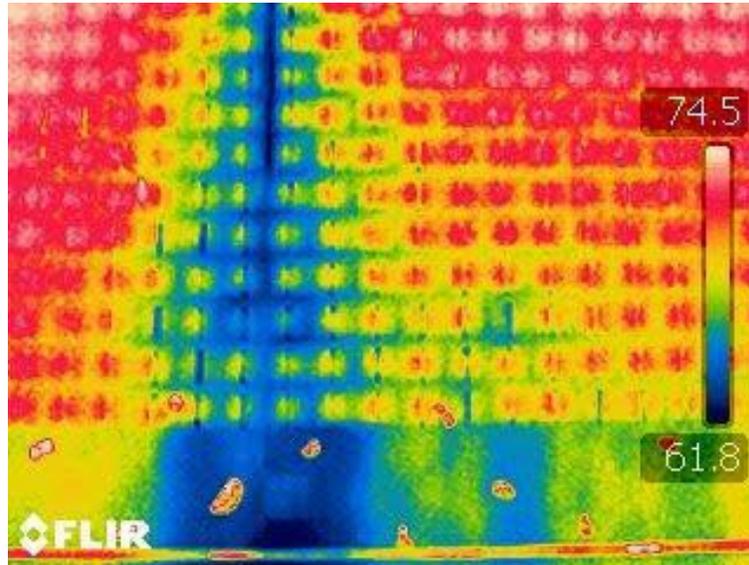
With the fact there is no air barrier, large cracks, and the sound reducing slits on some walls, the main problem here is air leakage. The outside air has many ways to get through to the inside causing the cool air to enter. Below is a thermographic image that shows the major air leakage, especially at the major crack:

As you can see, the crack is the blue section which has a much lower temperature (~62°F) compared to the rest of the wall (~70°F) due to the cold air entering. Along with this, the walls are uninsulated and solely rely on their own makeup for insulation. At such a low R-Value (2.8) and air leakage, both a better form of insulation and air barrier needs to be implemented. Note: For the entirety of this project I only considered the exposed walls to be included in calculations and propositions such as heat loss and material costs.

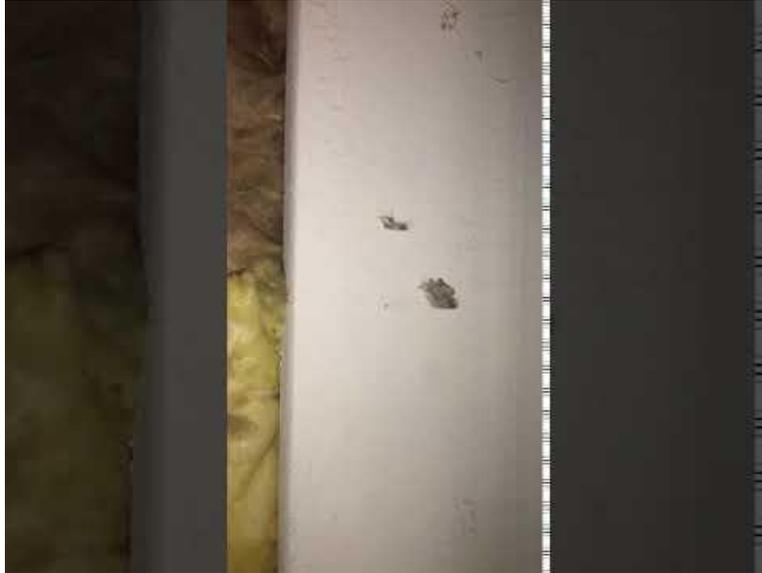
There is major air leakage at the structural columns lessening the potential R-Value of the insulation and letting cold air easily pass through. In the video below, you can see the air flow in the open cavity of the two I-beams:

We need to implement more insulation here along with an air barrier that is continuous with the wall retrofit.

For the columns, the solution must be continuous with the plywood wall finish. To start, fiberglass insulation will be stuffed into the cavity between both I-beams. This will both increase the R-Value and remove the space that air can easily flow through. On top of that will be the air barrier. Closed cell spray foam, which is a dense form of polyurethane foam, will be sprayed to seal and provide an air barrier to the columns. This spray foam will meet with the liquid air barrier from the walls on each side, making a continuous air barrier for the walls of the gym. The plywood will then be attached and also meet with the walls on both sides. Below is a CAD drawing showing the before and after of this proposed solution:
